# MUSEUM HISTORICUM BOSNIAE ET HERZEGOVINA

The Historical Museum of Bosnia and Herzegovina:  
Preservation of a Modernist Gem in Sarajevo

DIPLOMA  
PROJECT

Czech Technical University in Prague  
Faculty of Architecture  
SS 2023/2024  
Ateliér Efler  
Supervisor: doc. Ing. arch. Tomáš Efler  
Student: Bc. Verda Mesihović

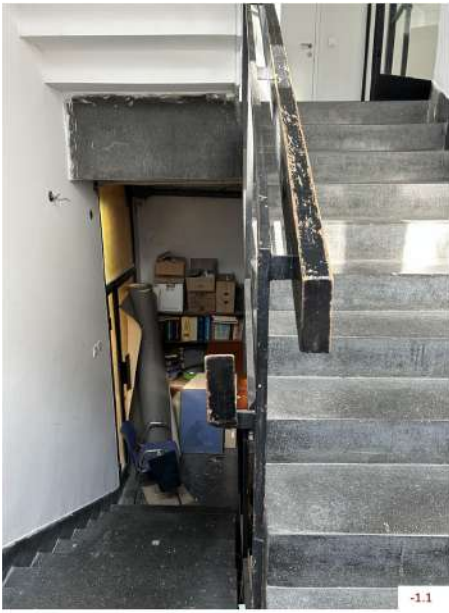
-1.1

- 1.1 Lack of storage; refurbishment of the stairs railing needed
- 1.2 Lack of storage; facilities not managed properly; door in poor condition
- 1.3 Lack of storage; refurbishing of walls and ceilings needed

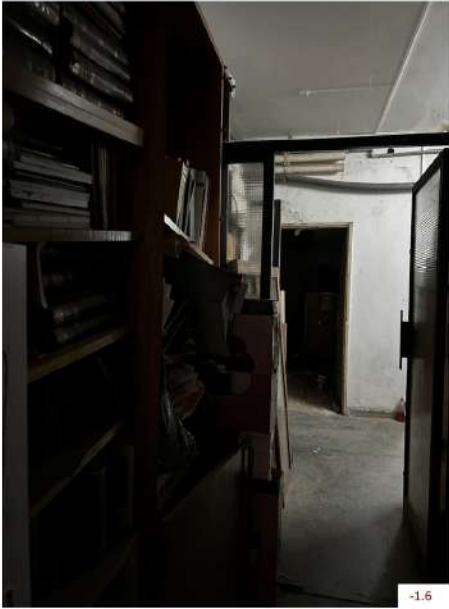
-1.6

- 1.6 Lack of storage; refurbishing of walls, ceilingss, flooring; door in poor condition; facilities not managed properly
- 1.7 Lack of proper storage; refurbishing of walls, ceilingss; windows in poor condition; facilities not managed properly

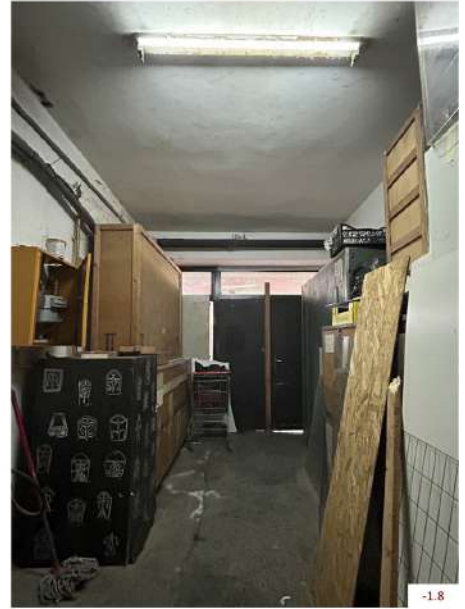
-1.8

- 1.8 Lack of storage; refurbishing of walls, ceilingss, flooring; door in poor condition; facilities not managed properly
- 1.9 Refurbishing of walls, ceilingss, flooring; facilities not managed properly

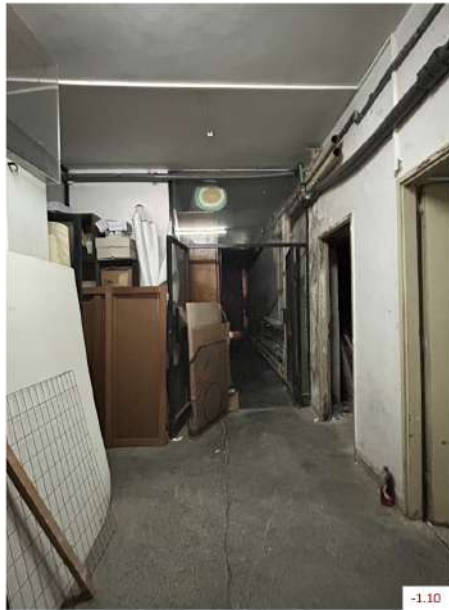
-1.10

- 1.10 Lack of storage; refurbishing of walls, ceilingss, flooring; door in poor condition; facilities not managed properly
- 1.11 Solving the cause of the problem outside (the room is below the Museum entrance platform), refurbishment of the whole room

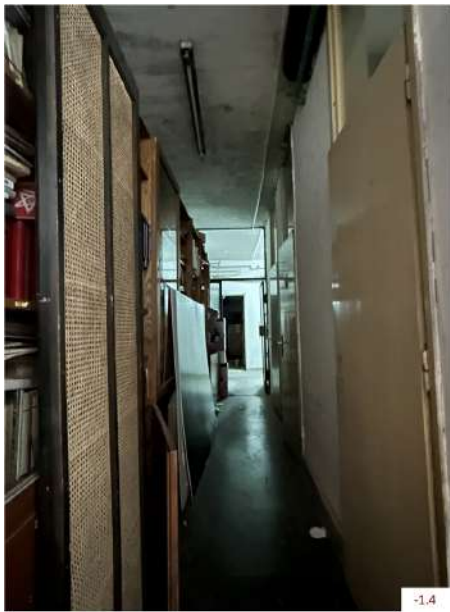
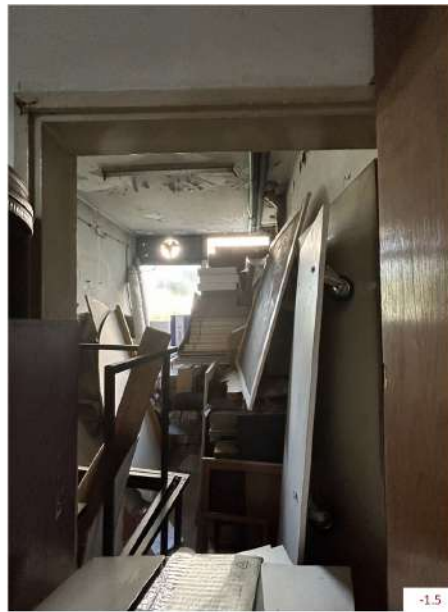
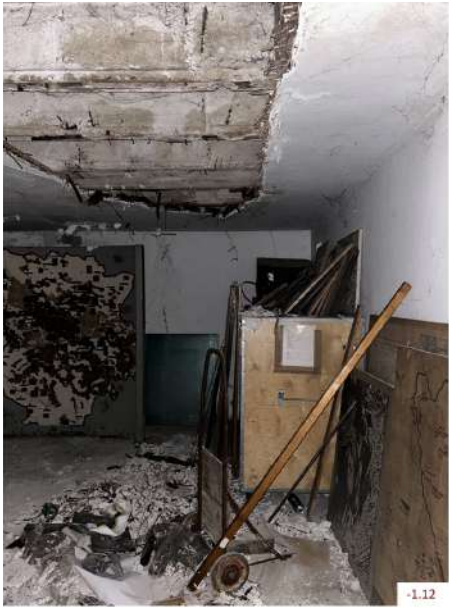
- 1.4 Lack of storage; refurbishing of walls and ceilings needed; doors in poor condition
- 1.5 Lack of storage; refurbishing of walls, ceilings; facilities not managed properly; windows in poor condition

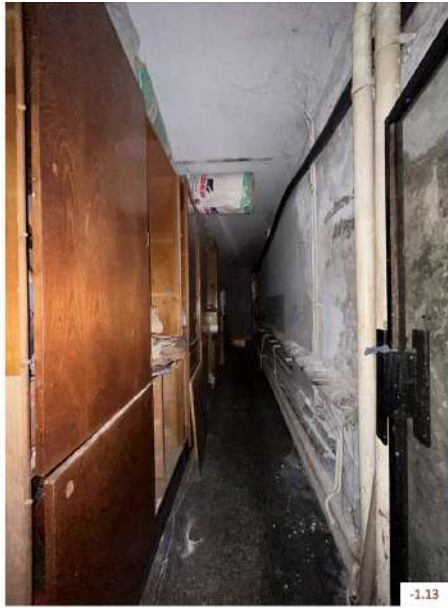
-1.13

- 1.12 Solving the cause of the problem outside (the room is below the Museum entrance platform), refurbishment of the whole room
- 1.13 Lack of storage; facilities in poor condition; refurbishing of walls, ceilings and flooring
- 1.14 Lack of storage; refurbishing of flooring; discontinued refurbishment of the area
- 1.15 Refurbishment of flooring
- 1.16 Refurbishment of flooring
- 1.17 Refurbishment of flooring
- 1.18 Refurbishment of flooring
- 1.19 Satisfactory state
- 1.20 Refurbishing of flooring; doors and windows in poor condition
- 1.21 refurbishment of stairs, flooring; doors and windows in poor condition; lack of proper exhibition space for the exhibits
- 1.22 Refurbishment of stairs, flooring; doors and windows in poor condition; lack of proper exhibition space for the exhibits

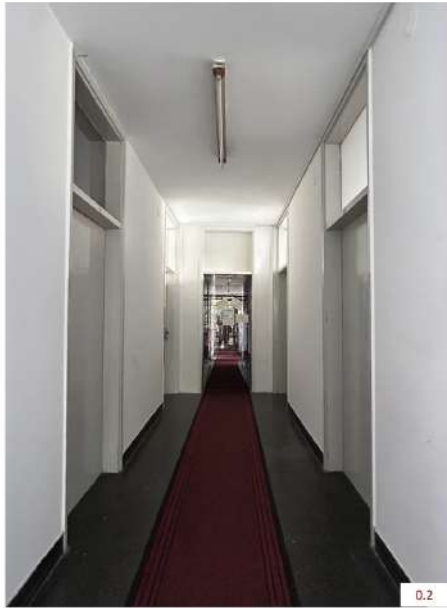
- 0.1 Satisfactory state; lack of storage
- 0.2 Satisfactory state; refurbishment of doors
- 0.3 Flooring refurbishment, doors in poor condition
- 0.4 Flooring refurbishment, doors and windows in poor condition
- 0.5 Flooring refurbishment, doors and windows in poor condition
- 0.6 Lack of storage; refurbishing of walls, ceilingss, flooring; door in poor condition; facilities not managed properly
- 0.7 Flooring refurbishment, doors and windows in poor condition
- 0.8 Flooring refurbishment, doors and windows in poor condition
- 0.9 Flooring refurbishment, doors and windows in poor condition
- 0.10 Flooring refurbishment, doors and windows in poor condition
- 0.11 Satisfactory state

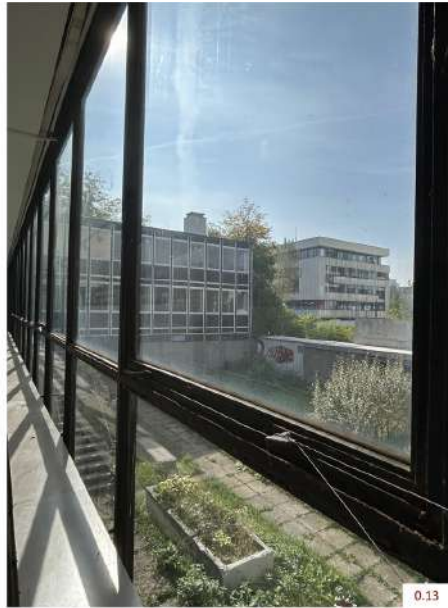
- 0.12 Satisfactory state
- 0.13 Satisfactory state; windows in poor condition
- 0.14 Satisfactory state
- 0.15 Satisfactory state
- 0.16 Satisfactory state; windows in poor condition
- 0.17 Satisfactory state; windows in poor condition
- 0.18 Satisfactory state; windows in poor condition; refurbishment of facilities
- 0.19 Satisfactory state; windows in poor condition
- 0.20 Windows in poor condition; stone elements in poor state
- 0.21 Windows and doors in poor condition, refurbishment of the bottom of the "floating cube" refurbishment of greenery
- 0.22 Windows and doors in poor condition, refurbishment of the bottom of the "floating cube" refurbishment of greenery

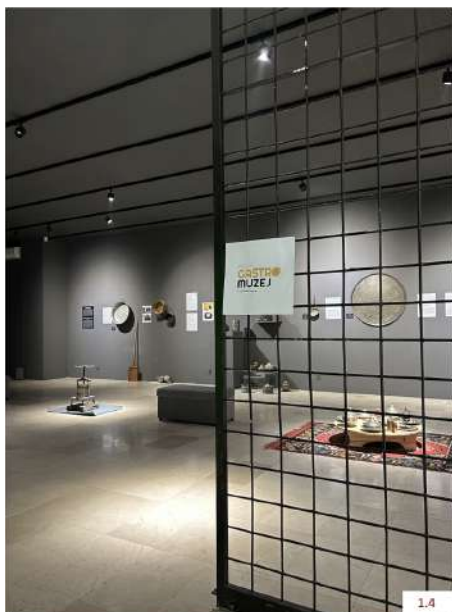
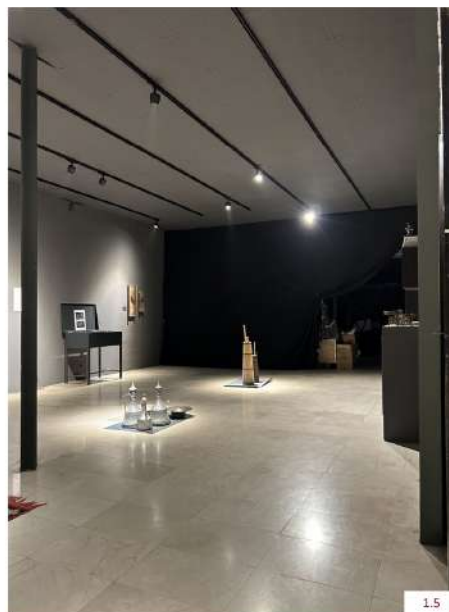
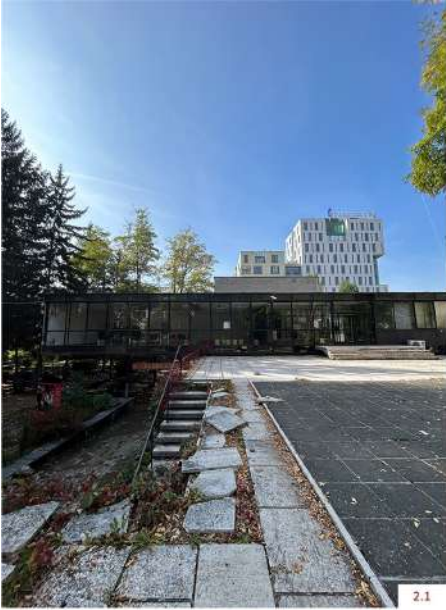
- 1.1 Corridor and offices to which it leads could benefit from full refurbishment
- 1.2 Stair railing refurbishment; facilities not properly managed
- 1.3 Satisfactory state
- 1.4 Satisfactory state
- 1.5 Satisfactory state; managing storage behind the curtain and providing more exhibition space
- 1.6 Satisfactory state; windows are new not matching the original appearance
- 1.7 Stair railing refurbishment, windows in poor condition
- 1.8 Satisfactory state
- 1.9 Satisfactory state; windows are new not matching the original appearance
- 1.10 Stairs and stair railing refurbishment; windows in poor condition
- 1.11 Satisfactory state

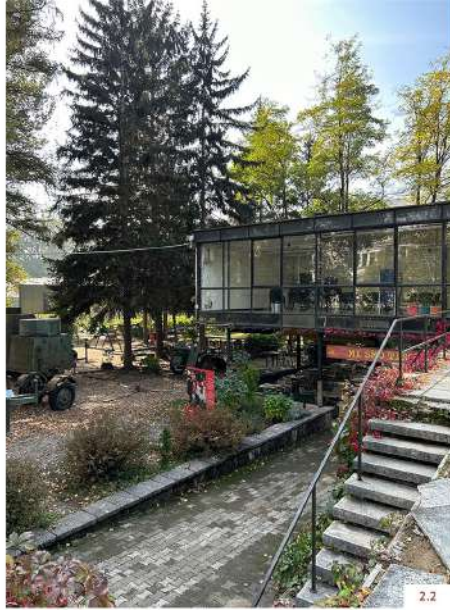
- 2.1 Damaged platform and stairs
- 2.2 Exhibits unprotected in the open; greenery covering the stairs
- 2.3 Damaged stairs to the courtyard; neglected courtyard and stone panels missing from the courtyard wall
- 2.4 Damaged wall of the courtyard; fenced greenery part neglected; façade damage - danger of stone panels falling from the cube
- 2.5 Platform damage and unplanned greenery
- 2.6 Greenery not in the original plan, possibly harming the structure
- 2.7 Platform pavement and fence ruined
- 2.8 Façade in poor condition; missing and broken stone panels; broken parts of glass; rusty metal elements
- 2.9 Main entrance stairs damaged and missing parts
- 2.10 Main stairs dangerously ruined; stone panels broken

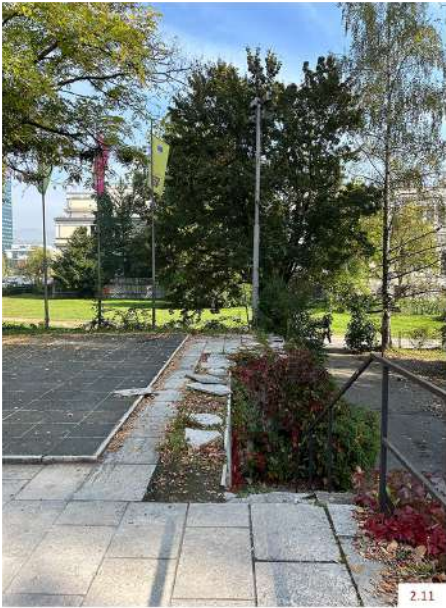
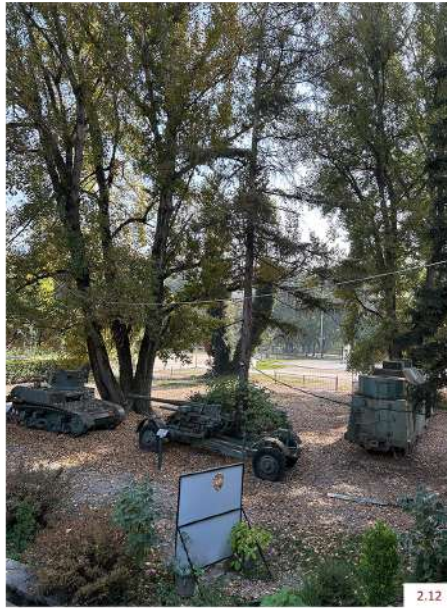
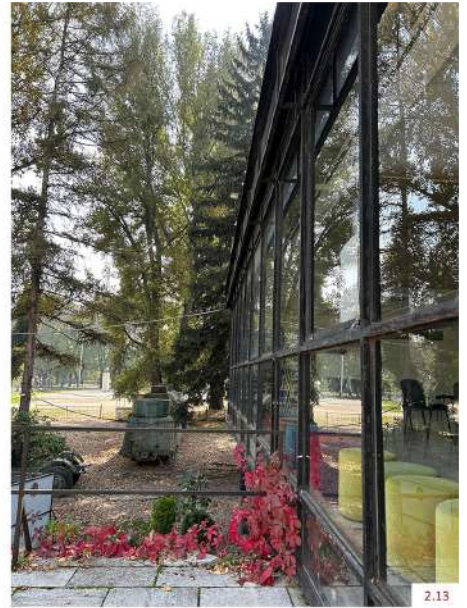
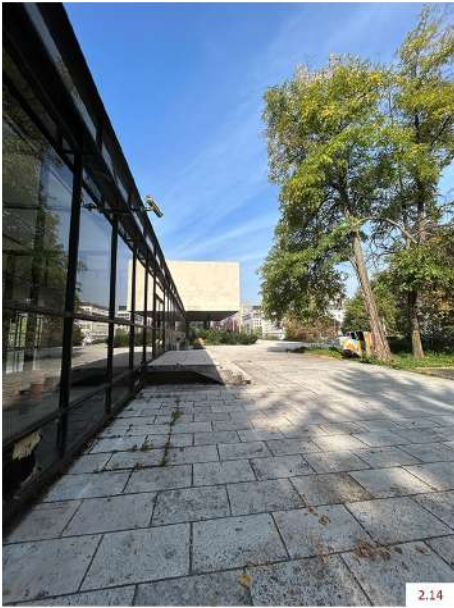
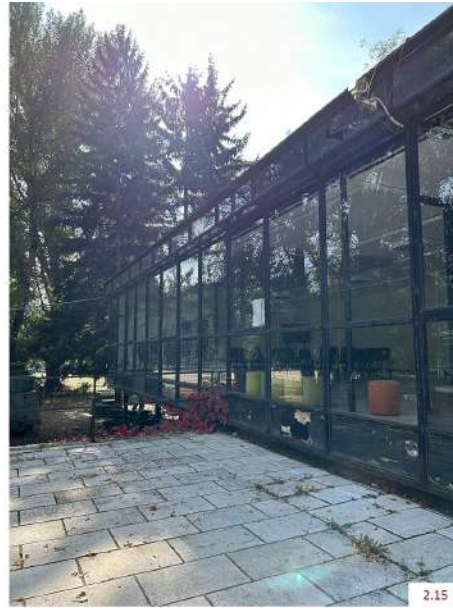
- 2.11 Greenery damage of the structure; platform does not have original appearance; paving ruined
- 2.12 Exhibits in the open space, unprotected
- 2.13 Windows in poor condition

- 2.14 Broken glass elements, doors and windows in poor condition; grass growing from pavement; stairs damaged
- 2.15 Broken glass elements; grass growing from pavement

- 2.16 Rusty metal façade elements, windows in poor condition; broken glass elements; differences in pavement; stairs damaged
- 2.17 Rusty metal elements; broken glass elements; air conditioning unified and placed without coordination; flower pots in poor condition

- 2.18 Greenery on the platform
- 2.19 Highly damaged main entrance stairs with breakages and missing parts
- 2.20 Damage on the façade (stone elements; plaster; marble); difference in pavement; lack of storage

- 2.21 Damage on the street-facing-wall on both sides (stone panels); damaged pavement

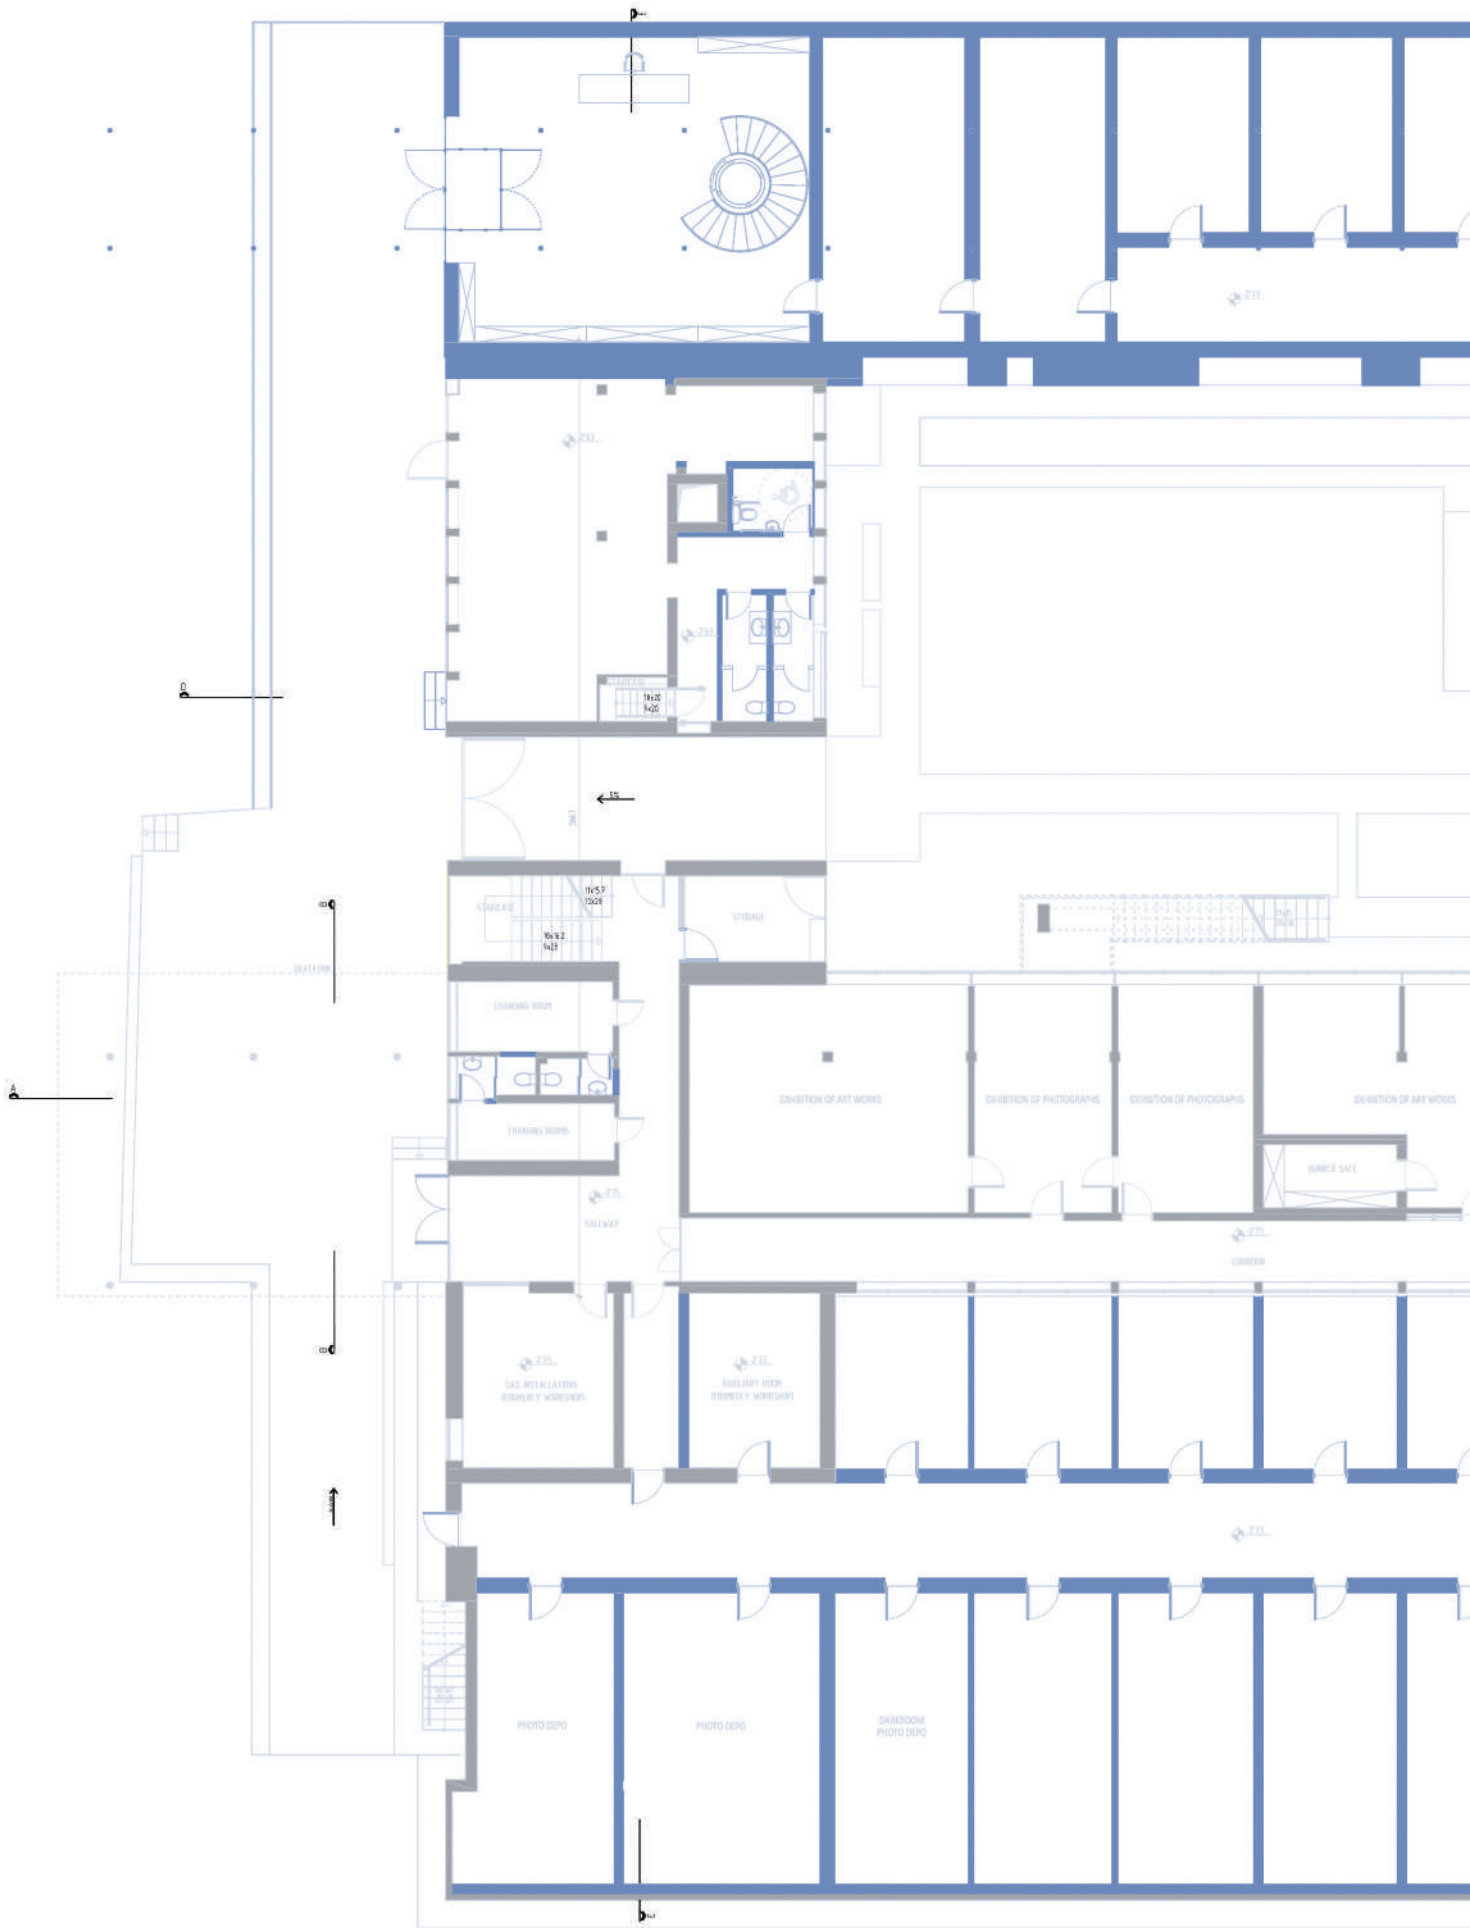
Basement Floor Plan

- existing/preserved structures
- existing windows
- existing coloured windows
- new structures
- new transparent windows

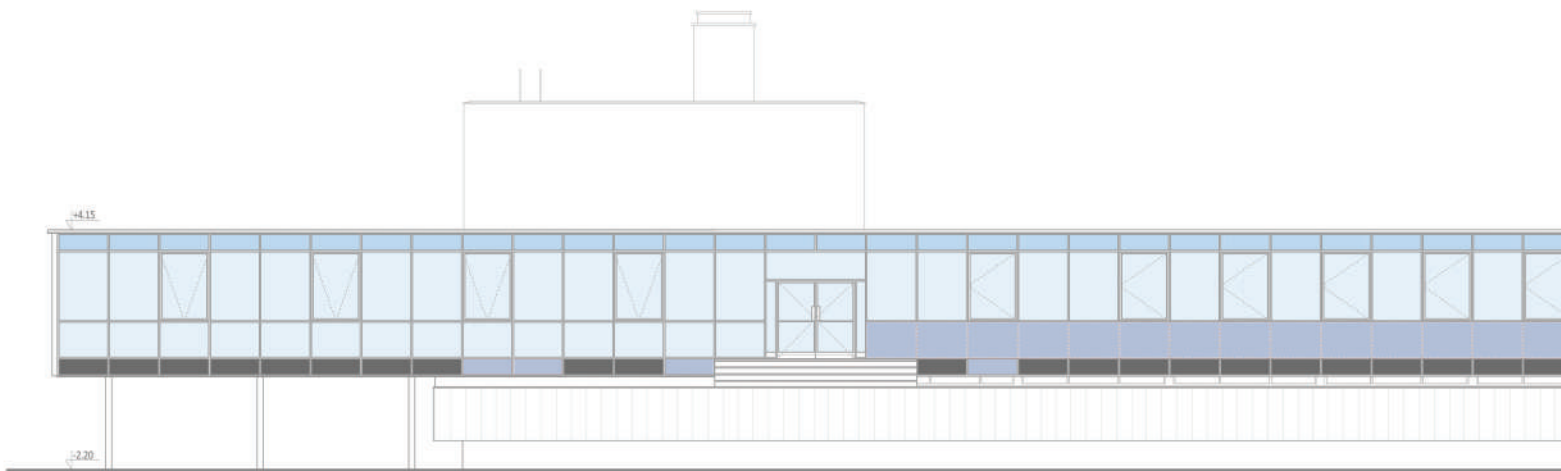
- existing/preserved structures
- existing windows
- existing coloured windows
- new structures
- new transparent windows
